# CASE STUDIES

The Enrich Bits and Tools process has been utilized in a number of case studies evolving various applications. These trails were performed by the clients.

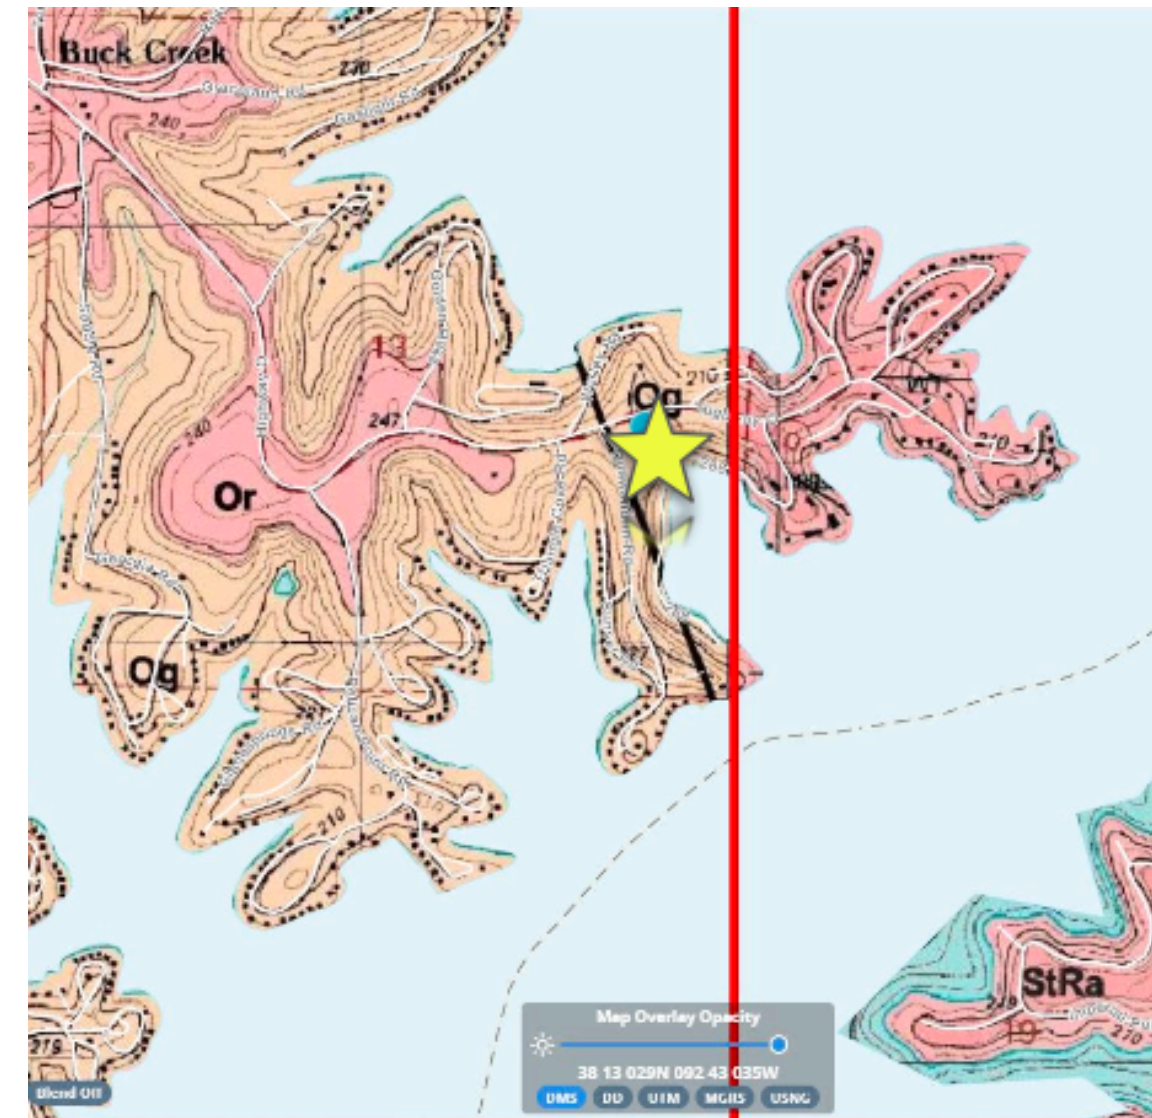
Middendorf, M.A., 2002, Bedrock Geologic Map of the Sunrise Beach 7.5' Quadrangle, Camden and Morgan Counties, Missouri: Missouri Department of Natural Resources, Geological Survey and Resource Assessment Division Open-file Map OFM-02-421-GS, 1 sheet.

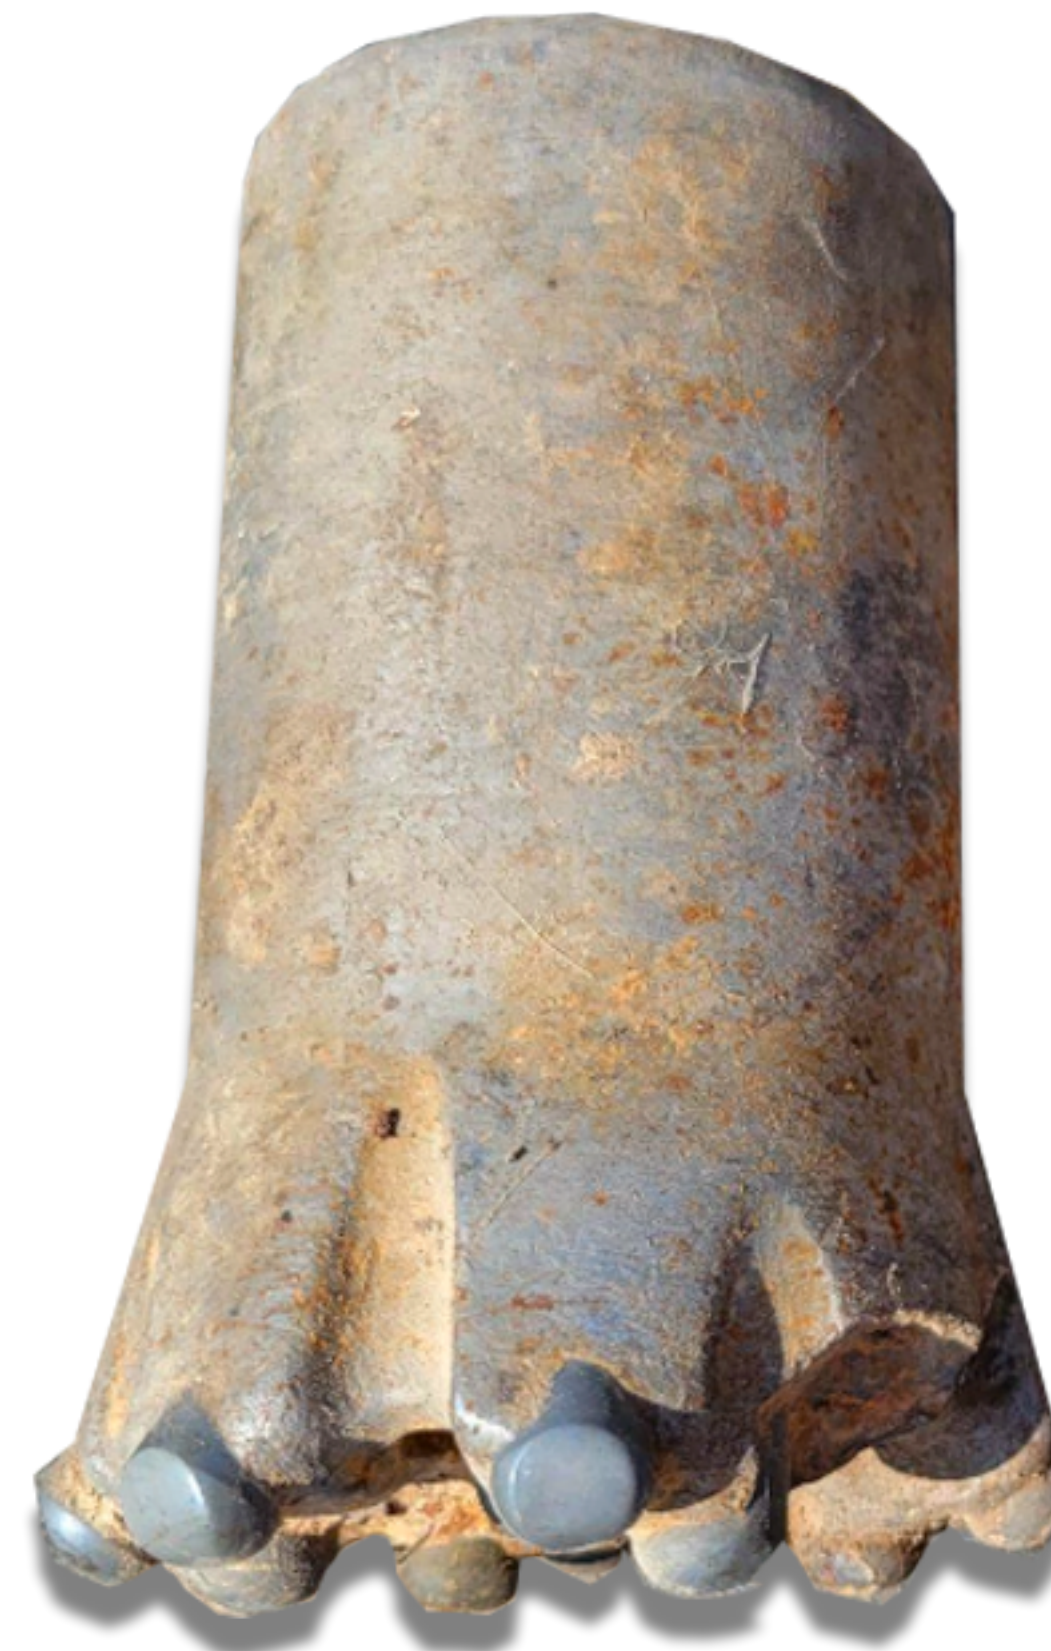
A **165% increase in bit life was measured**. The final footage drilled was 12,999 borehole feet before a button was rolled. The bit life of the same manufacturer was tested without treatment and the final borehole footage was recorded at 4,907 borehole feet.

4,907 ft Untreated bit

The percentage increase accurately reflects the increase in performance in comparison to the same geologic conditions of infield results. Notice the amount of wear around the body of the bit after lasting over 2X longer.

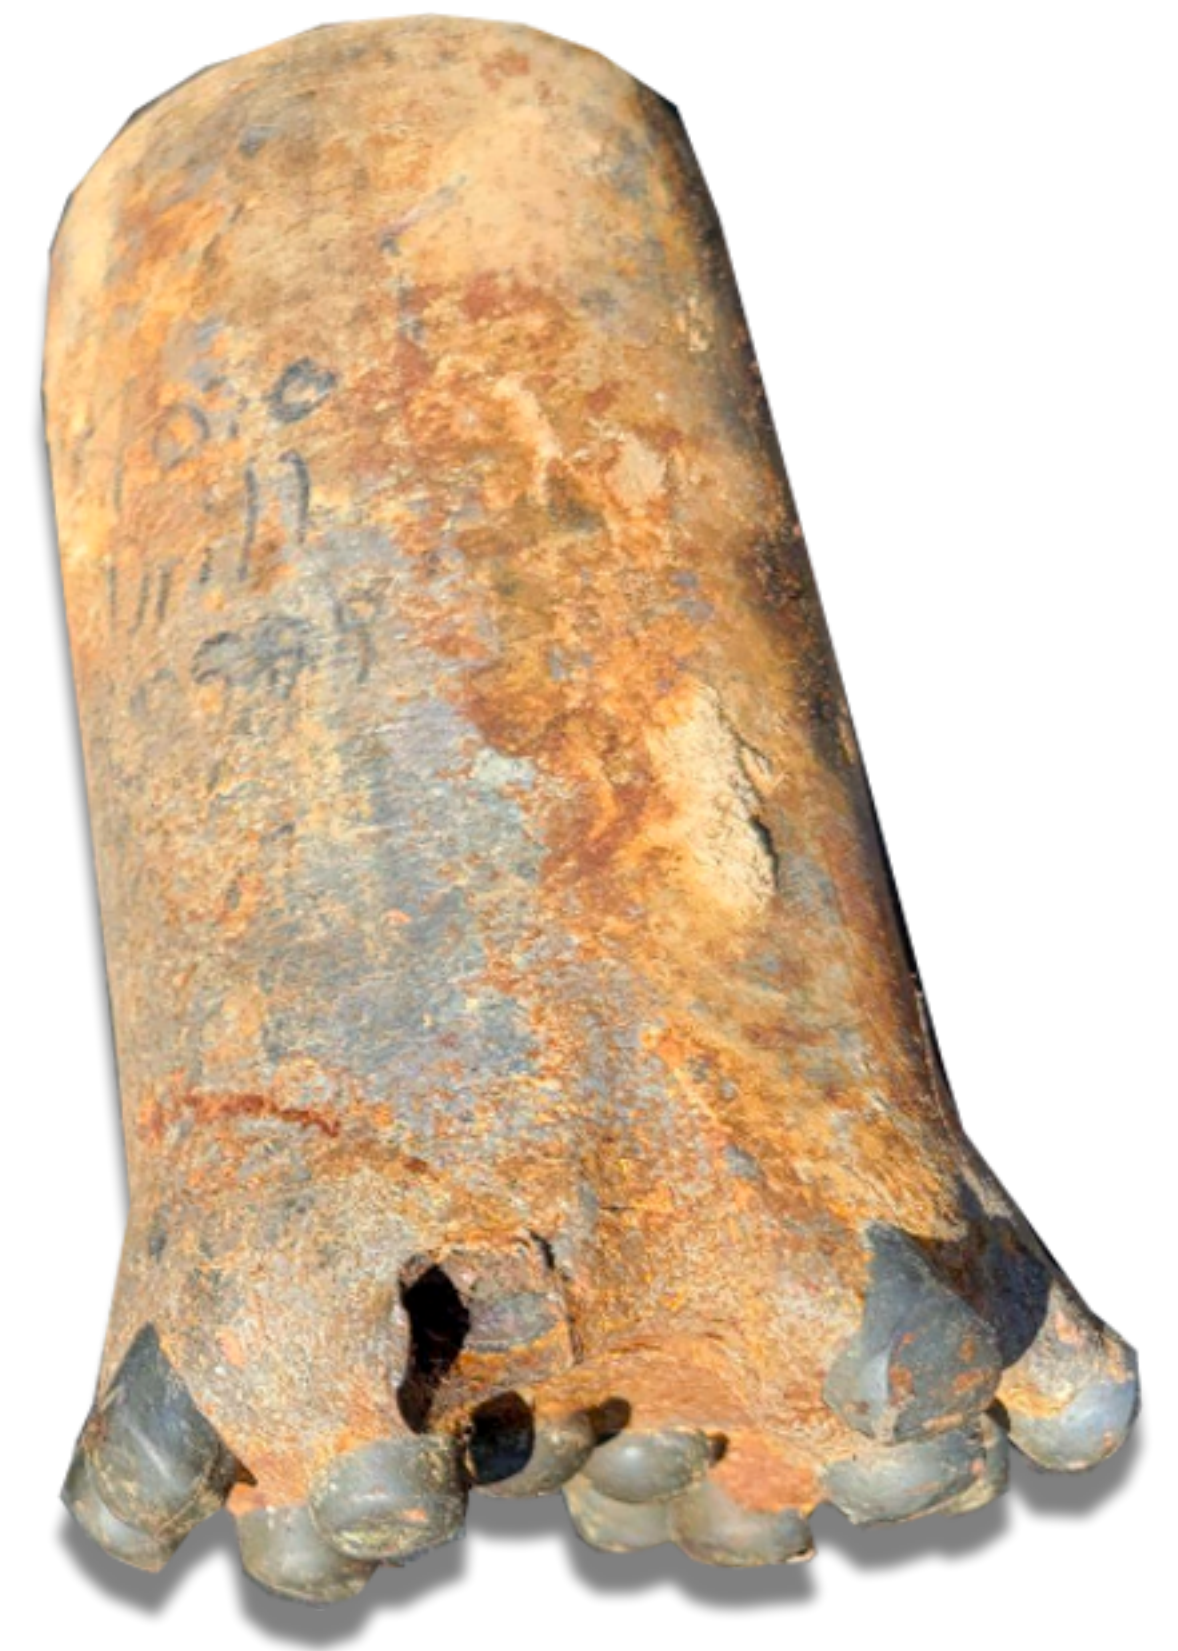
12,999 ft Treated bit

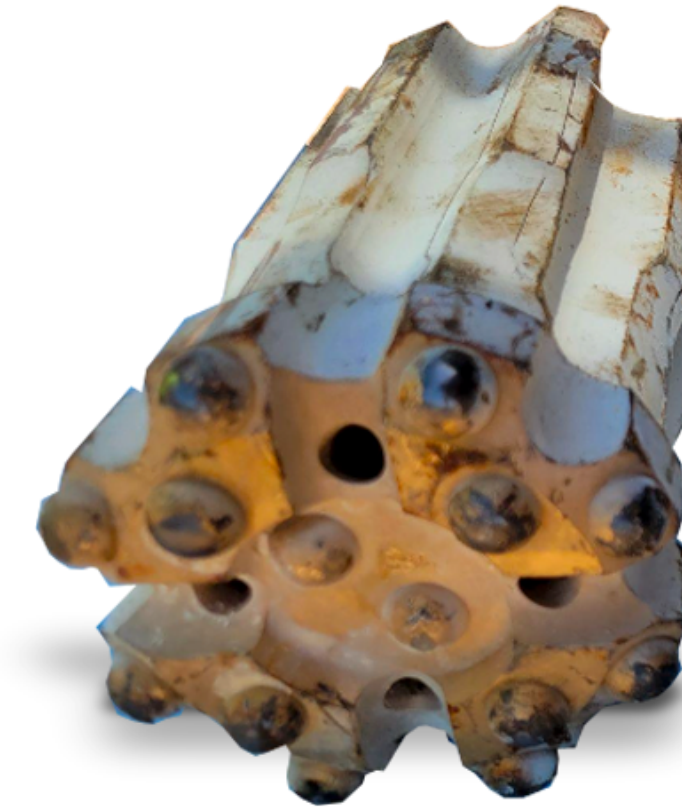
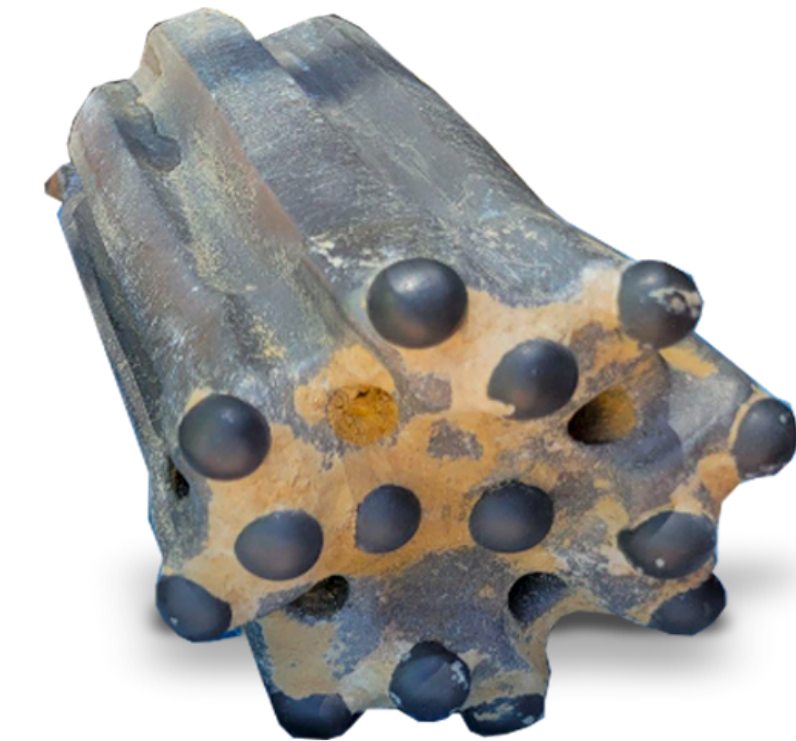
Photo compares wear on the face of the bits.

Unused bit

Treated bit

A treated retract bit was trialed in the same geology. On August 25th, 2023, a photograph of the treated retract bit after drilling ~3000 borehole feet was taken to observe the wear in comparison to a brand-new bit. The bit treated with the Enrich Bits and Tools process shows minimal wear to the body of the bit even after operating for 3/5th of a typical bit's operating life. The carbide button wear is normal while the body appears unphased for the distance drilled.

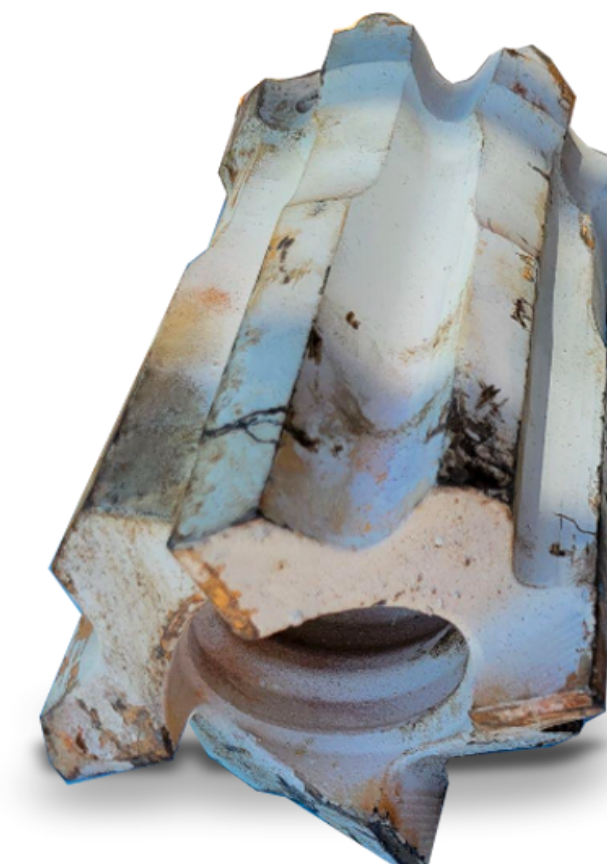
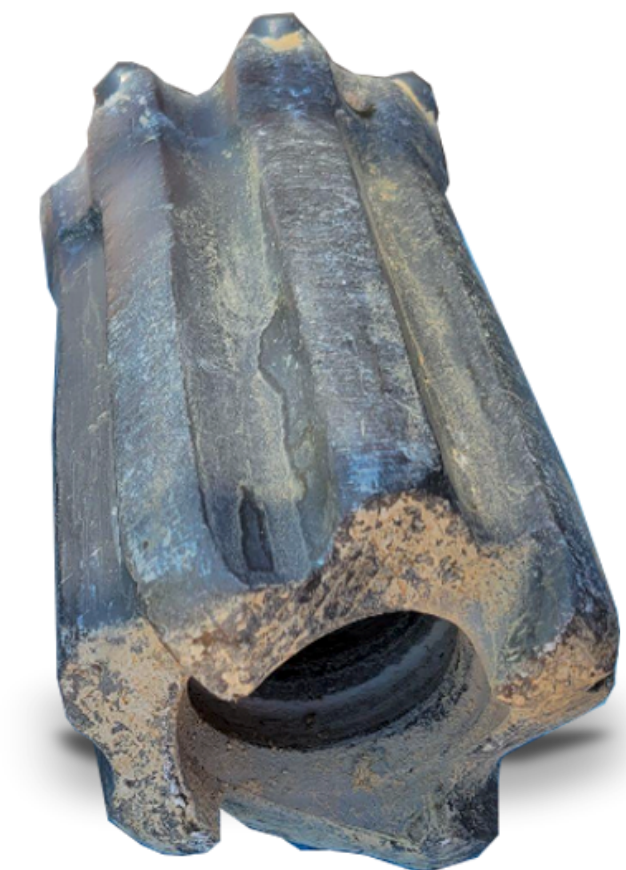
Photo compares wear on the body of the bits.

Unused bit

Treated bit

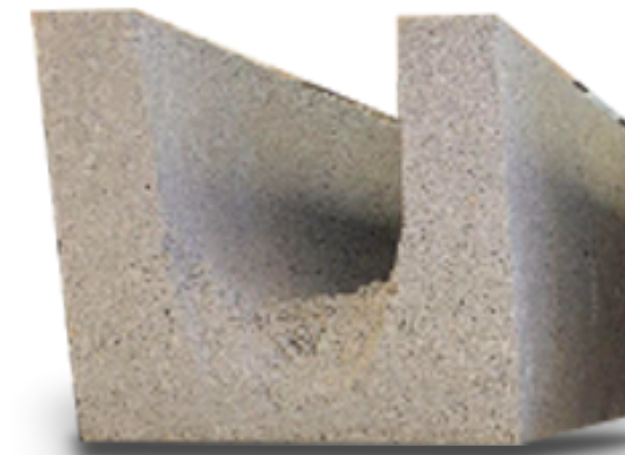
8" SBBB

In a 3 year long study completed in September 2023, a series of trials were conducted utilizing the Enrich Bits & Tools process on 8 inch block molds.

**Test 1:** Treated block molds were installed. Test concluded ~90,000 cycles prior to replacement. This is approximately 270,000 blocks.

**Test 2:** To confirm baseline measurement the untreated molds were installed. The untreated replacement molds lasted ~40,000 cycles prior to replacement.

**Results: 125% increase**

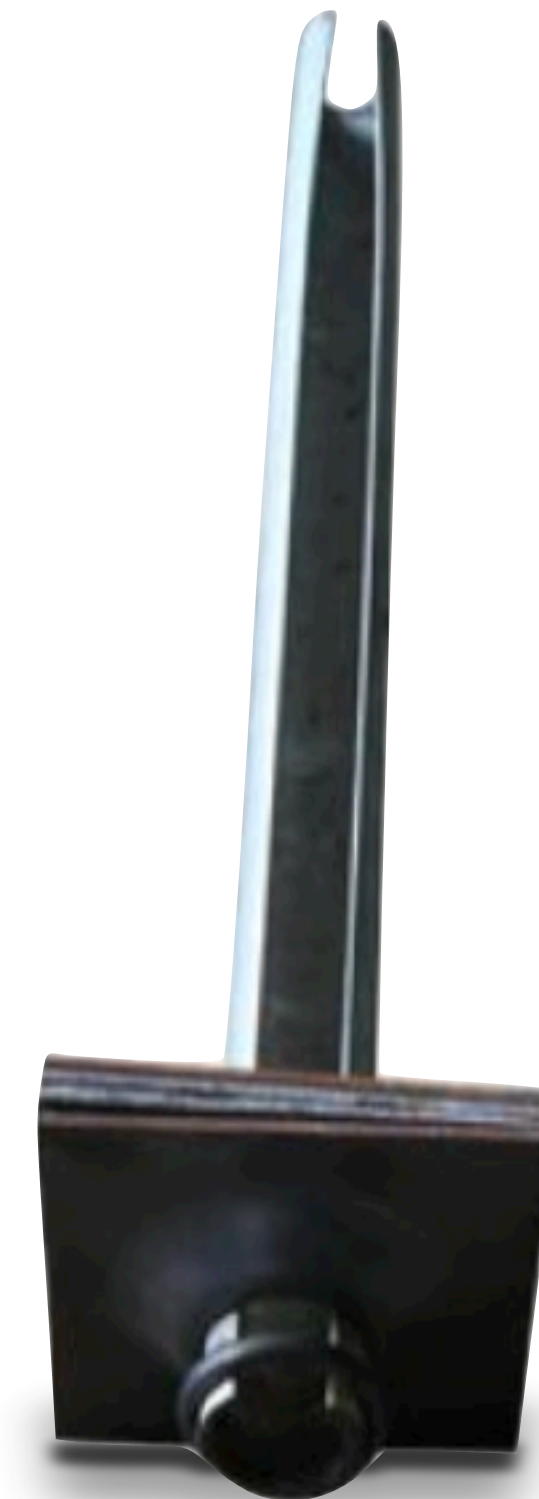
Split-set  
roof bolt

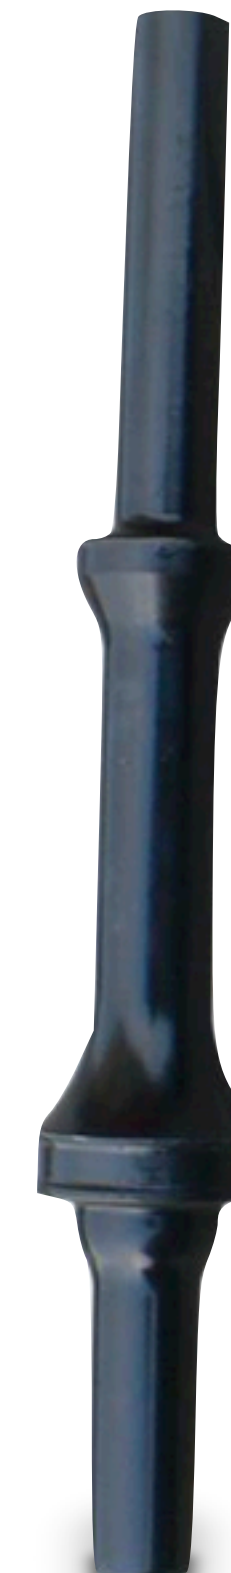
Treated  
Bolt Driver

An Enrich Bits and Tools treated split-set bolt driver was put into service on a Cannon Roof Bolter.

The machine installed 286 units of 39MM x 6' Galvanized Roc-Set split-set roof bolts. The seasoned operator reported the life of a typical split-set driver has been ~100 bolts per driver prior to treatment.
